# OGLALA SIOUX OF PINE RIDGE RESERVATION HOUSING AUTHORITY TRIP REPORT

## Assessment of Mold and Moisture Conditions

### Final Report

July 12-16, 2004

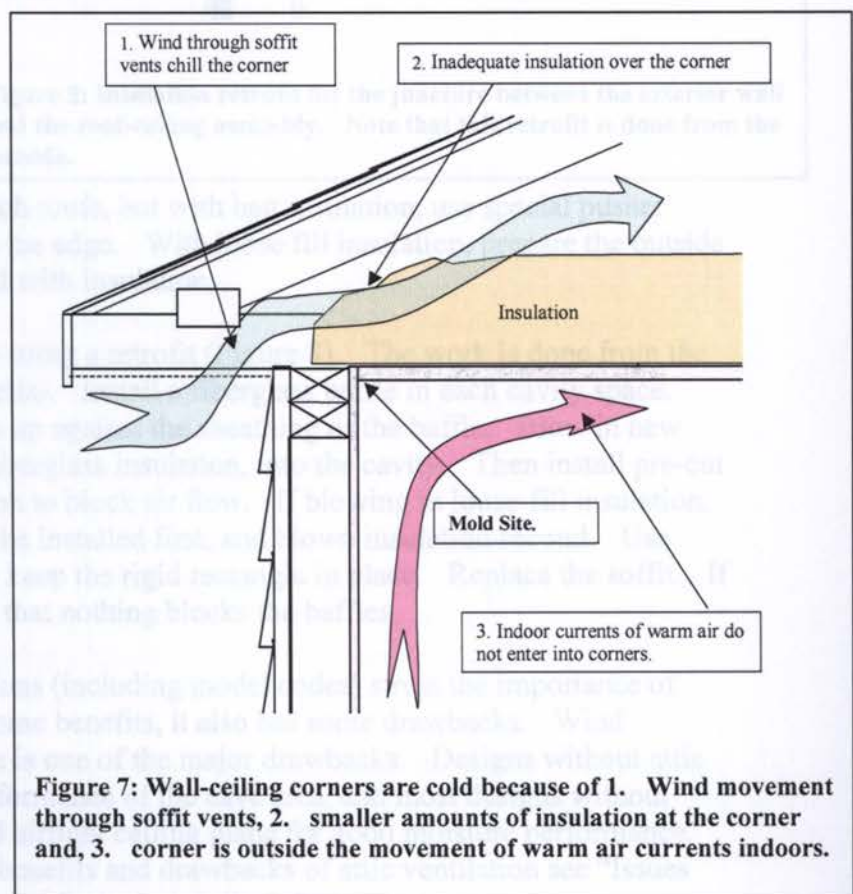
Three reasons why the exterior wall/ceiling juncture gets cold (Figure 7):

1. Cold wind may enter through soffit vents and pass through the porous insulation material, degrading its thermal performance.

2. The insulation may have been poorly installed resulting in reduced amounts of insulation in the corner.
3. The geometry of the corner usually means that slow-moving currents of warm air may not be able to reach into the corners.

Dark spots occur where the interior surfaces are the coldest, the hardest place to insulate effectively. In new construction, use a raised-heel truss and ensure the installer pays special attention to the wall-roof joint. It is difficult to carefully insulate the exterior edge of the attic,

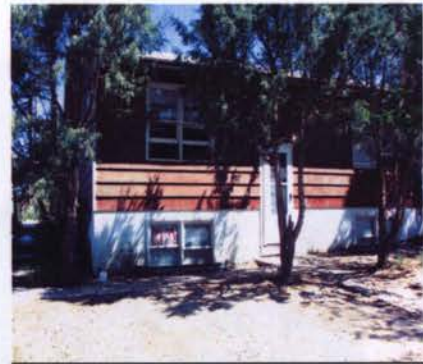
**Figure 1 – 95 E. Ridge.****Mold and Moisture Conditions:**

Mold was visible within the basement and downstairs bathroom, major mold in the shower stall (Figure 2).

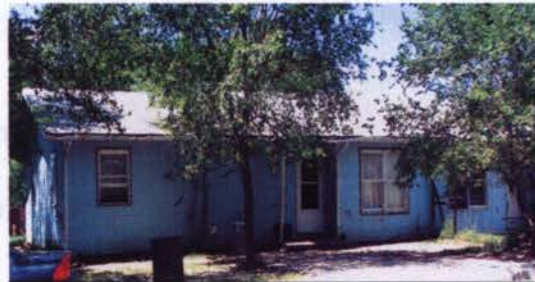
**Figure 1 – 185 E. Ridge.****Mold and Moisture****Conditions:**

Condensation-based mold was severe in one bedroom and present in two other bedrooms. Minor surface mold was visible on the bathroom tub/shower surround. Other moisture problems were apparent.

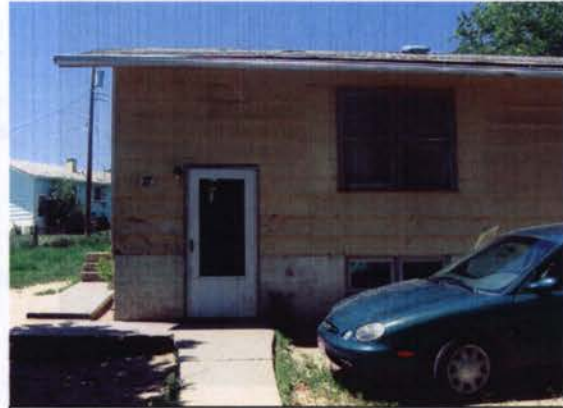
Figure 1 – 27 N. Ridge.

The site sloped dramatically from back to front. Erosion from rainwater drainage had carved deep ruts in the yard and undermined the concrete stairs and landings (Figure 2). The walk at the front of the house dammed rainwater against the foundation. Water flowing against the foundation had caused water damage to the concrete block structure (Figure 3) and provided opportunities for water leakage into the basement.

The roof drainage system was in need of significant maintenance and replacement of missing components, such as downspouts, leaders, and splashblocks. Rainwater concentrated by the downspouts at the base of the foundation can result in water entry into the basement (Figure 4). In the case of the front walk, the roof drainage system concentrated rainwater in a location that pooled against the foundation.

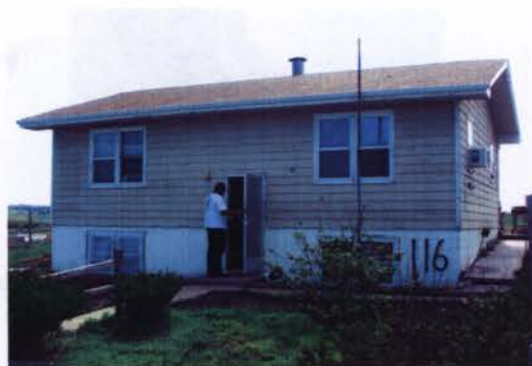
Figure 1 – 116 Wounded Knee Housing

**Mold and Moisture Conditions:** Minor surface mold was on the tub/shower surround and ceiling of the main bathroom. Some moisture damage was present in the basement bathroom. Winter humidifier use on the landing of the stairs had resulted in mold contamination in that area, and likely contributed to moisture problems in other areas of the home.

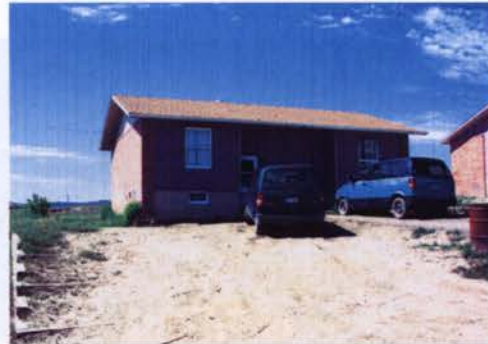
Figure 1 – 408 Mandersen.

**Mold and Moisture Conditions:** Significant mold growth was on the basement walls. Minor mold problems were in the bathroom and at the wall/ceiling junctures of one bedroom. The house had serious site drainage and rainwater management issues.
